Figure 001: Photo showing area of mortar loss and subsequent failed repair

Figure 002: Photo showing area of large sections of failed mortar joints typical of both towers above the level of the first floor

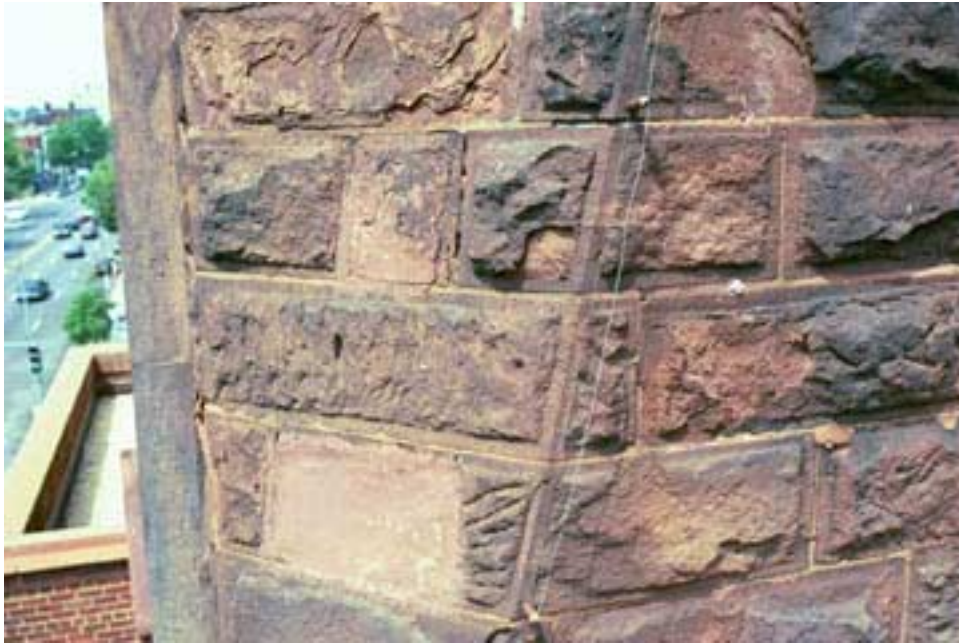
Figure 003: Photo showing area of cementitious patching and penetrations created during earlier campaign to control pigeon population.

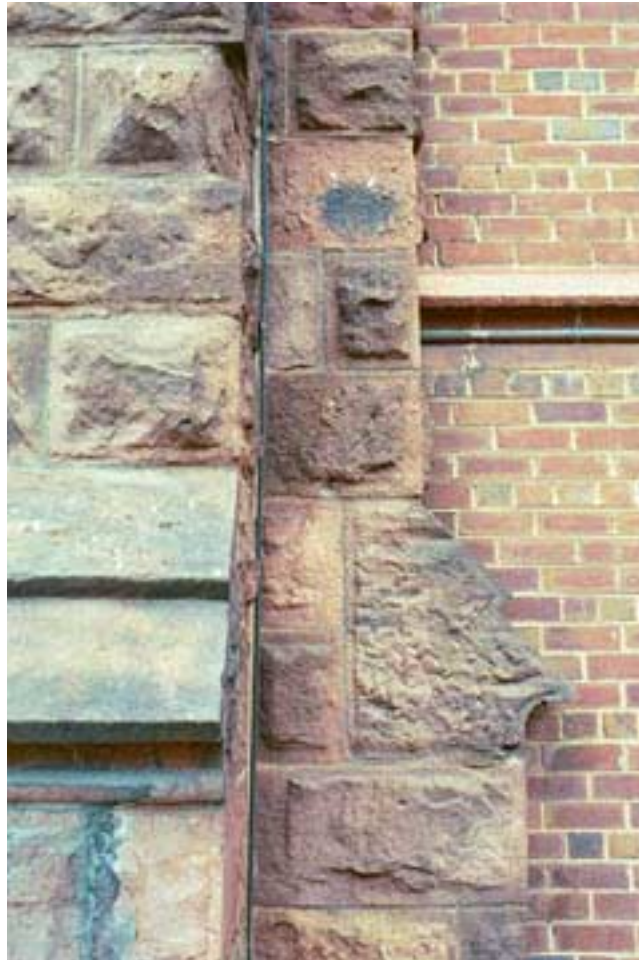
Figure 008: Photo showing areas of stone that are performing well (Condition of walls improves closer to the ground with most of the significant damage at the very peaks of the two towers.)

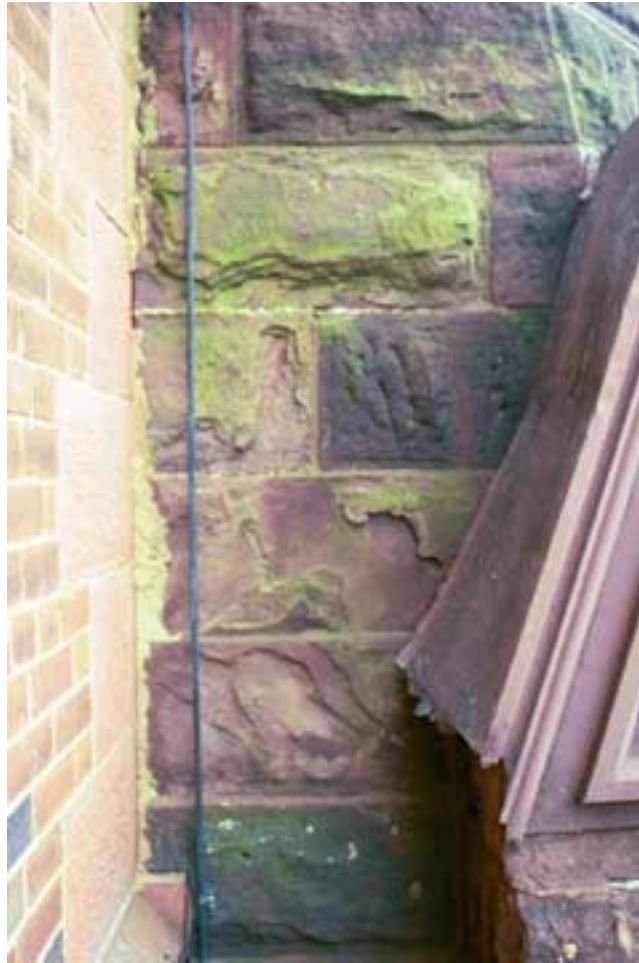
Figure 009: Photo showing area of delaminating stone surface, poorly attached metal cap over spire capping stone, organic growth and penetrations in the stone caused by the lightning rod grounding cable.

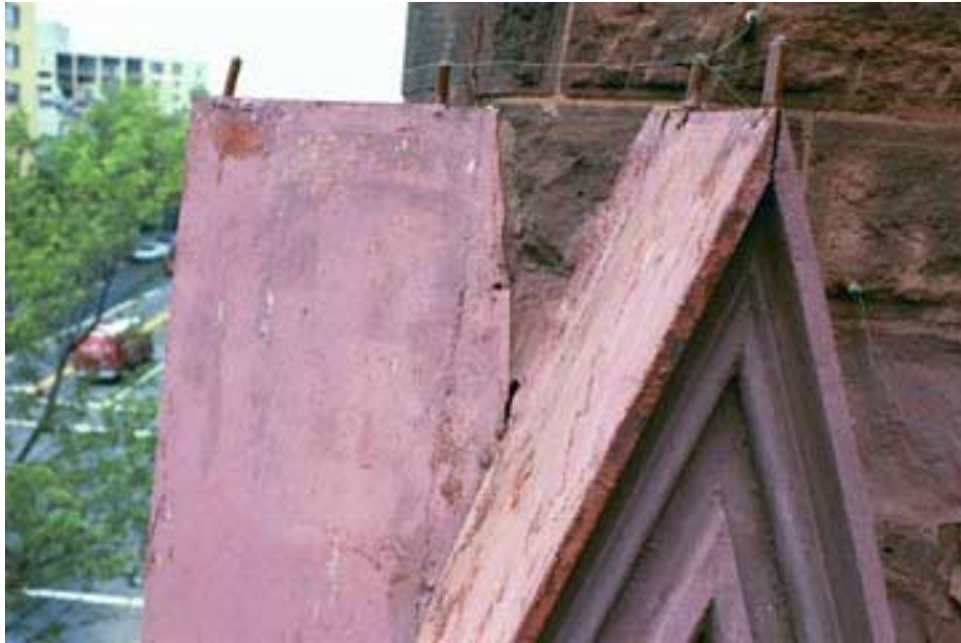
Figure 010: Photo showing area of rusted metal decorative cap, with large hole and unsealed flashing around connection at stone on tower face

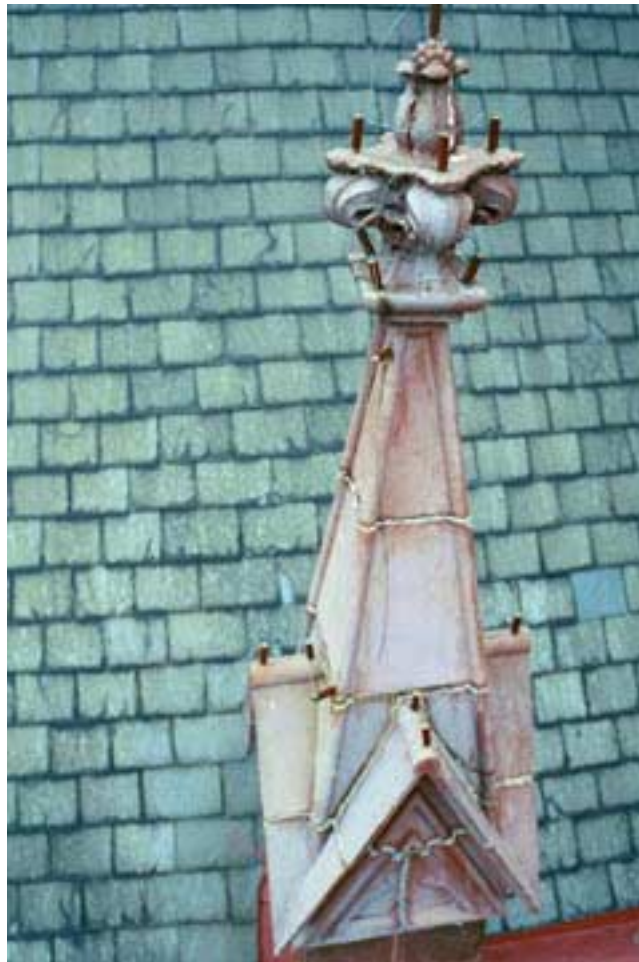
Figure 011: Photo showing terracotta minaret with multiple penetrations and superficially applied caulk over mortar base (need to determine stability of each minaret and need to repair as necessary)

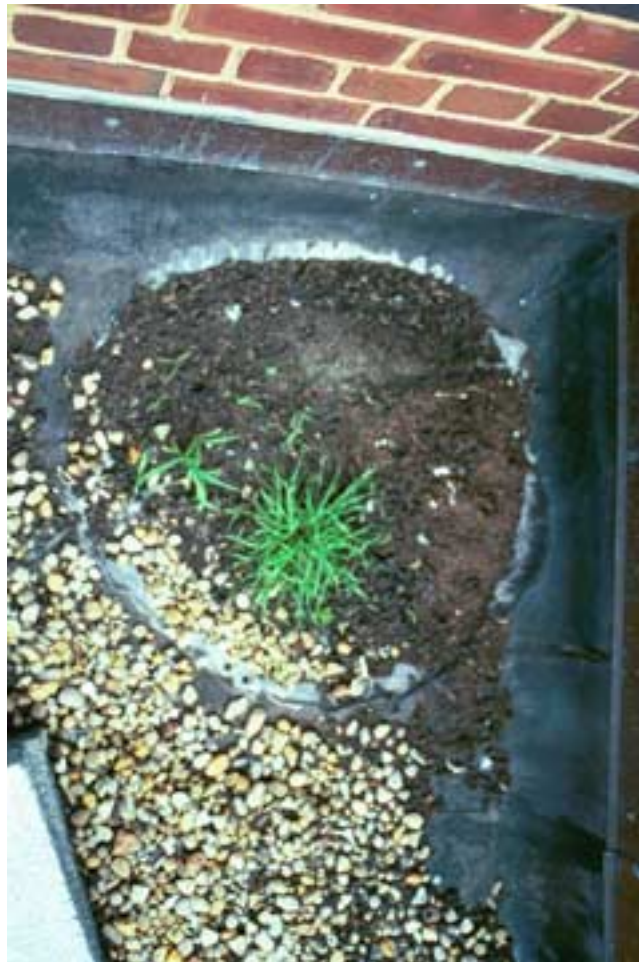
Figure 012: Photo showing clogged drain on flat roof over dormitory wing. Debris appears to be combination of guano and nesting materials.

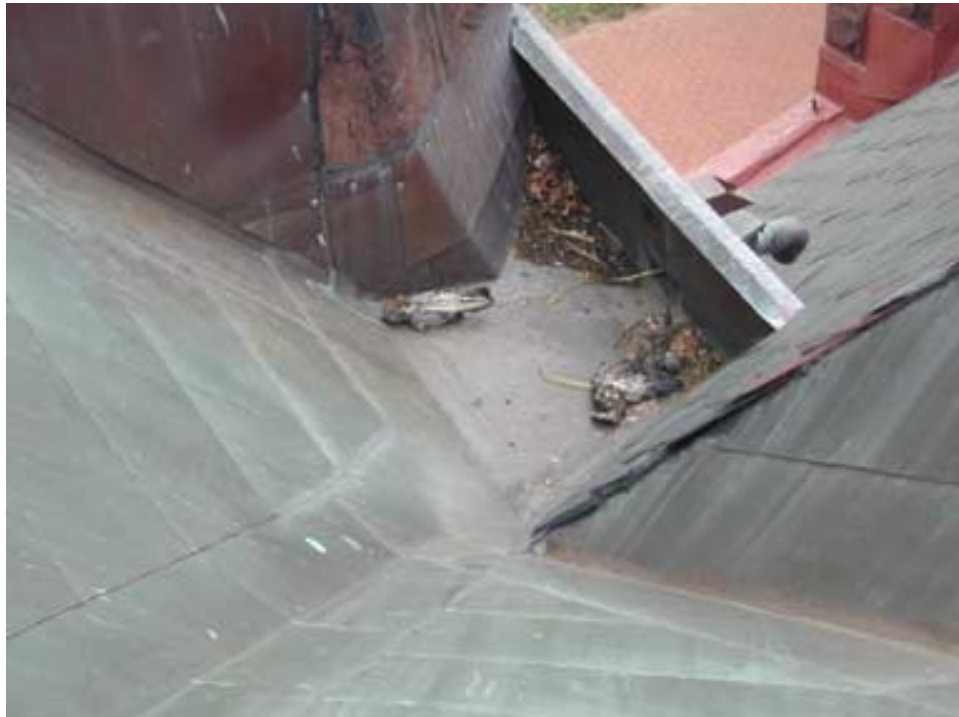
Figure 018: Photo showing general condition of roof drainage system at base of tower spires

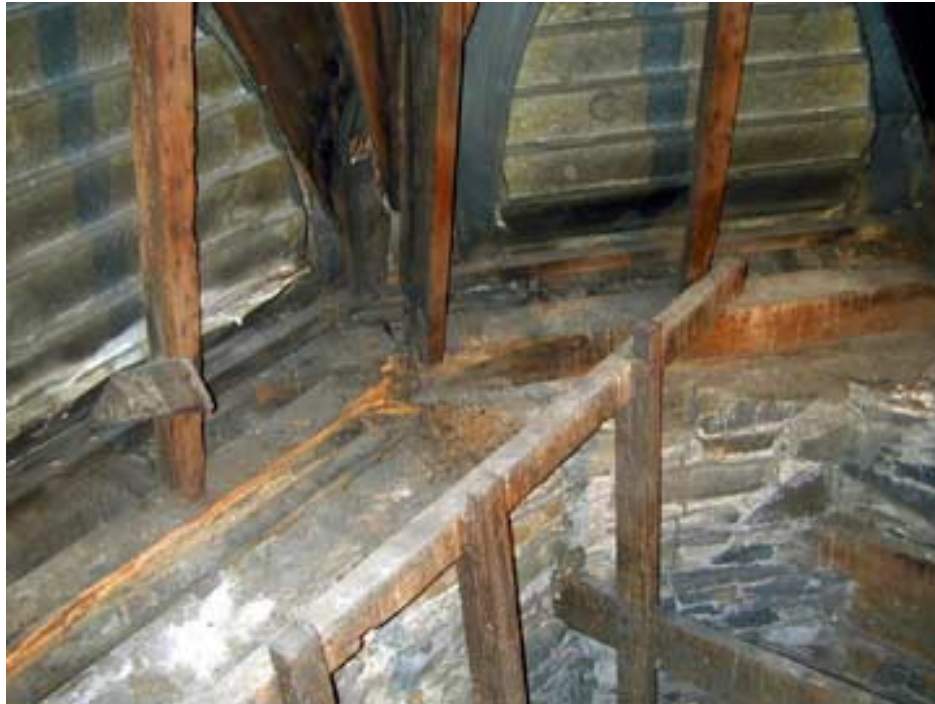
Figure 019: East Tower – Photo showing area of rot running the length of the sill plate

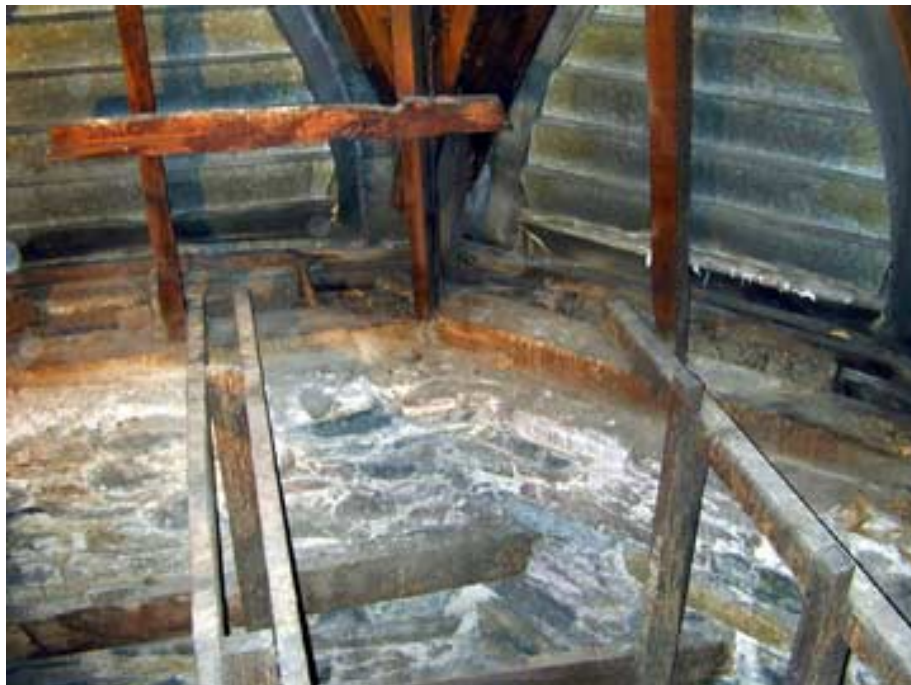
Figure 020: East Tower - Photo showing horizontal members that are attached with vertical studs to pocketed horizontal beams (they appear to be anchoring the sill plate in place)

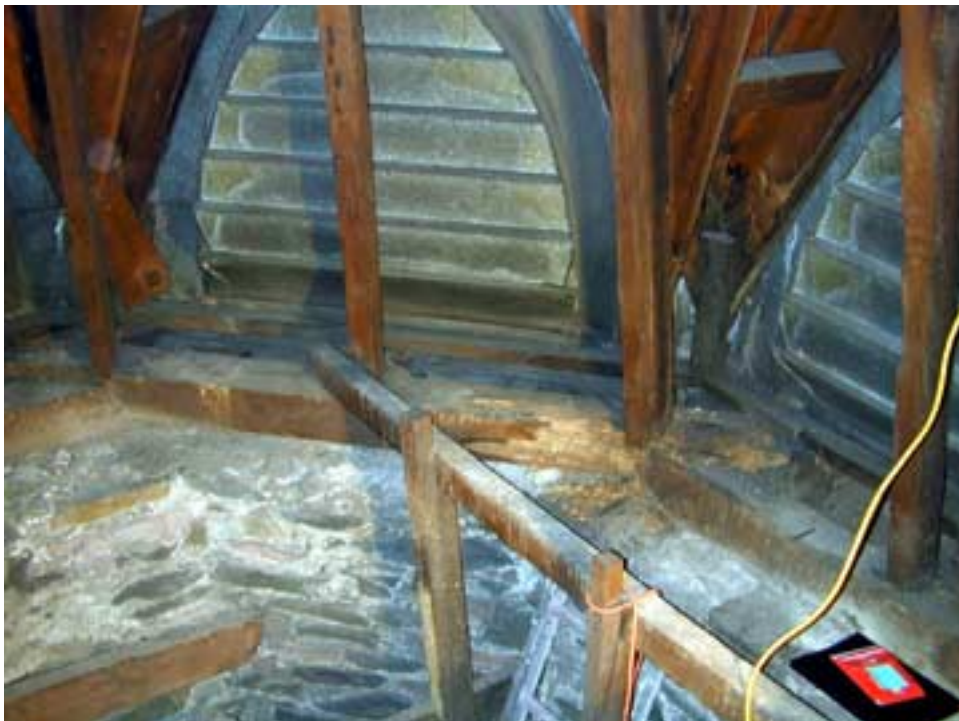
Figure 022: East Tower - Photo showing additional area of dry rot at intersection of two sill plates and vertical spire support

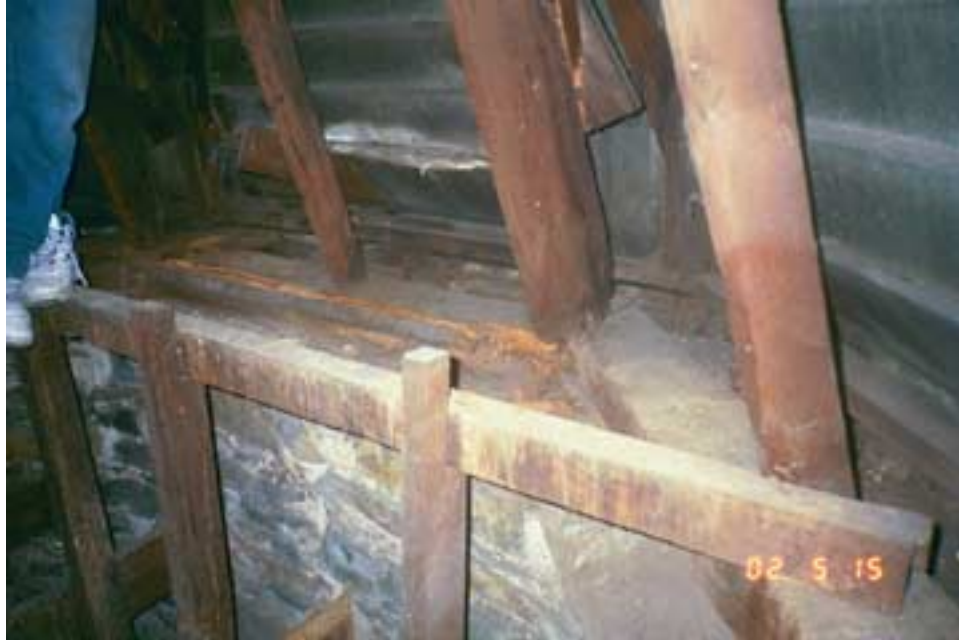
Figure 023: West Tower- Photo showing sill plate with rot and decay sufficient to compromise the entire length of the plate from vertical support to vertical support. Intermediate support is resting on hollowed out sill plate as well thus provided no additional vertical support for spire along exposed façade.

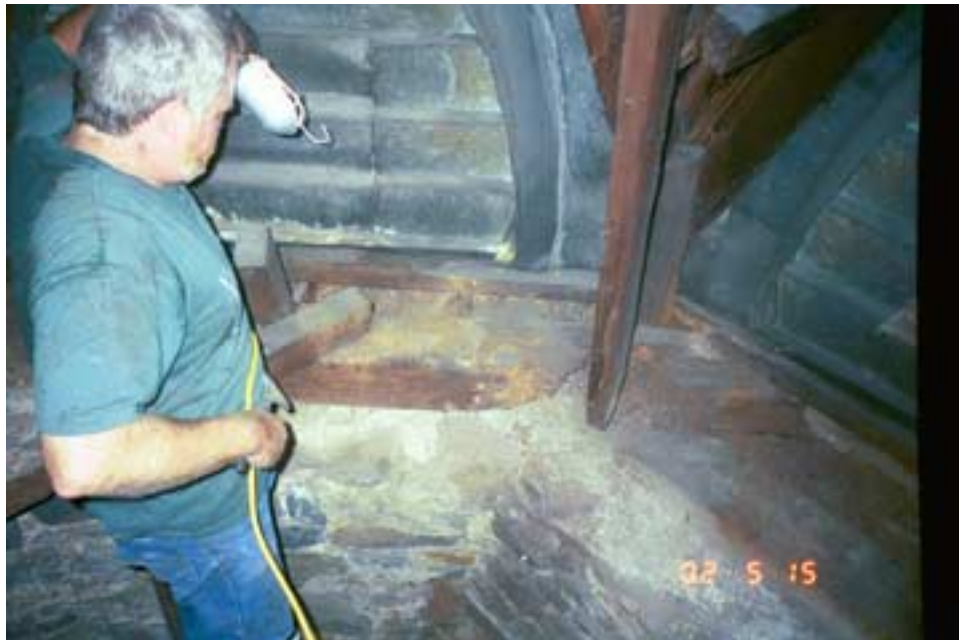
Figure 024: West Tower - Photo showing total failure of sill plate at intersection of vertical support and lapping sill plate (for adjoining section)

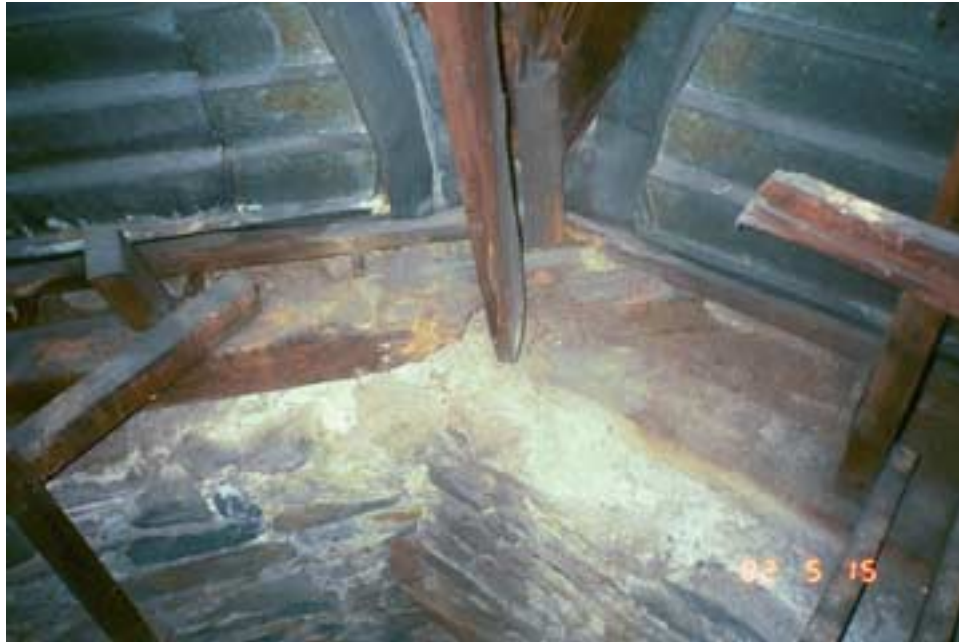
Figure 025: West Tower - Photo showing failed lap joint of sill plate (typical)

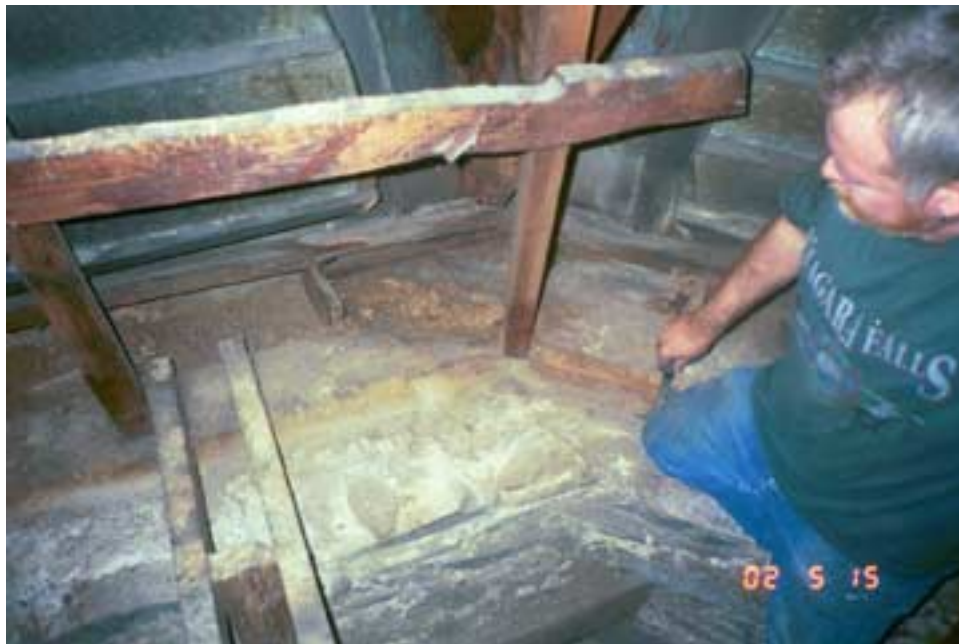
Figure 026: West Tower - Photo showing failed lap joint at sill plate (typical)

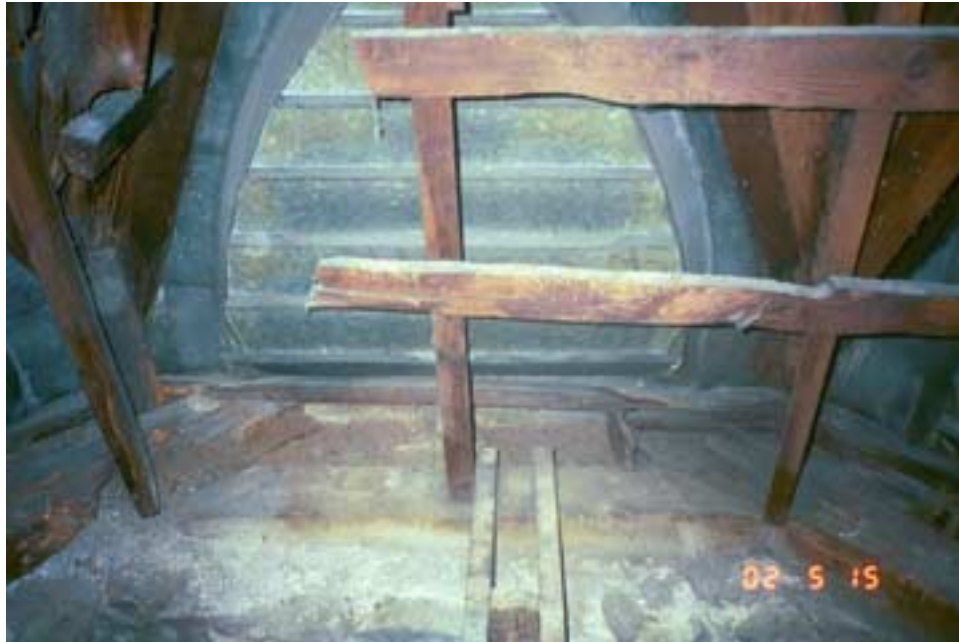
Figure 027: West Tower - Photo showing failed sill plate, lap joint (left), galvanized decorative exterior without any ventilation capacity, deteriorated one-by material

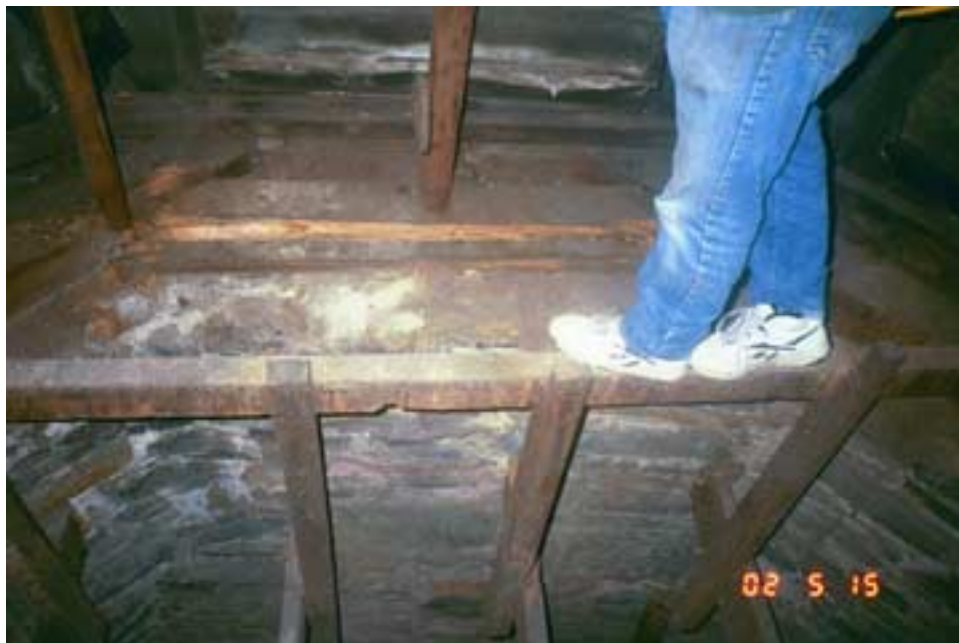
Figure 028: West Tower - Photo showing generous stone ledger suitable for repairing structural damage

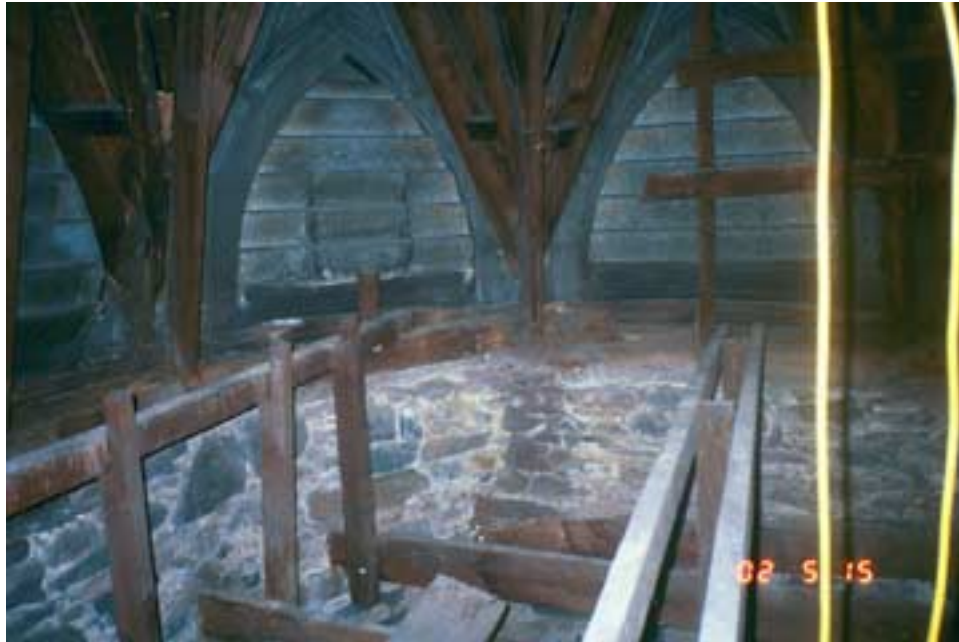
Figure 029: West Tower - Photo showing typical cross section of interior of tower at level of spire

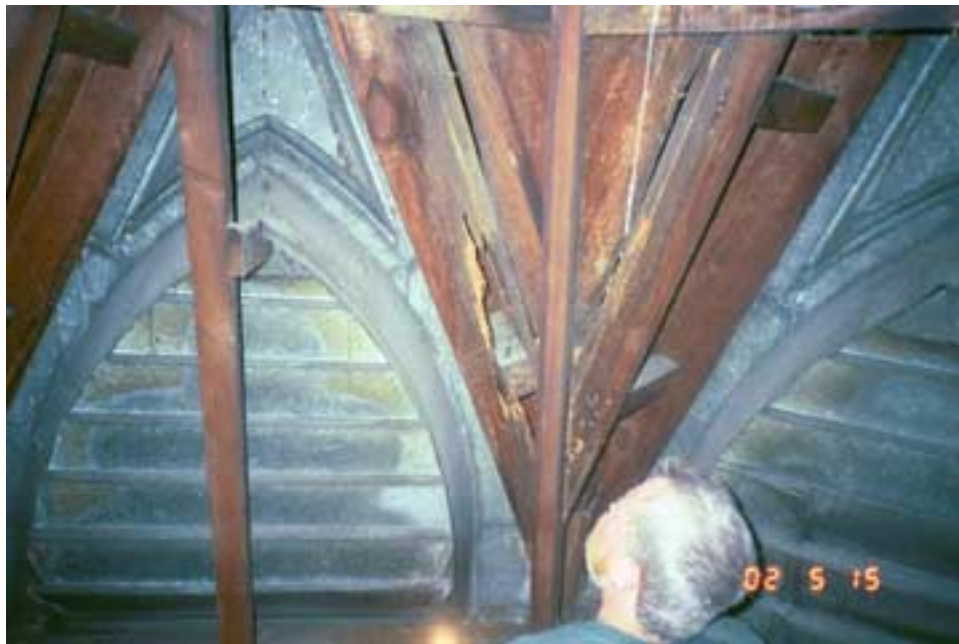
Figure 030: West Tower - Photo showing area of compression damage caused by loss of vertical support at corner of spire (damage has been compounded by insect infestation and dry and wet rot)
