Sandstone Conservation Assessment East & West Towers

Prepared for
Luther Place Memorial Church
Washington, DC

Submitted by
John Milner Associates, Inc.
Alexandria, Virginia
September 2002

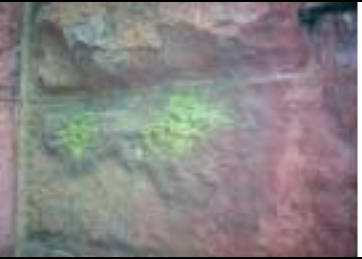
<i>Condition</i>	<i>Description</i>	<i>Repair</i>	<i>Example Photograph</i>
Biological Growth	Surface growth or coloration indicative of biological colonization. May be of varying thicknesses, colors, or biological origin	Remove by chemical cleaning

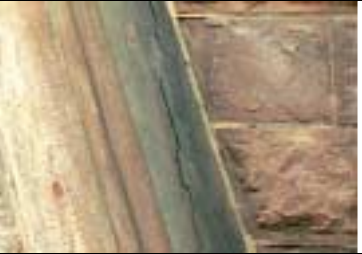
Cracking	A fracture in the stone of variable width or length that could result in the movement of adjacent parts, potentially constituting structural failure or weakness or allowing water intrusion.	Clean out crack and repair with cementitious grout. A pin may also be required.

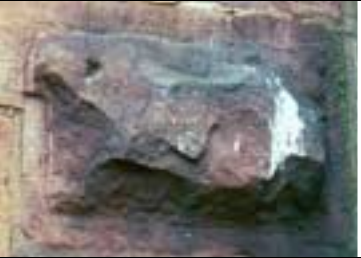
Guano	The accumulated excrement of birds. Typically contains nitrogen, phosphoric acid, and potash. Guano may cause staining and encourage pests.	Remove by chemical cleaning

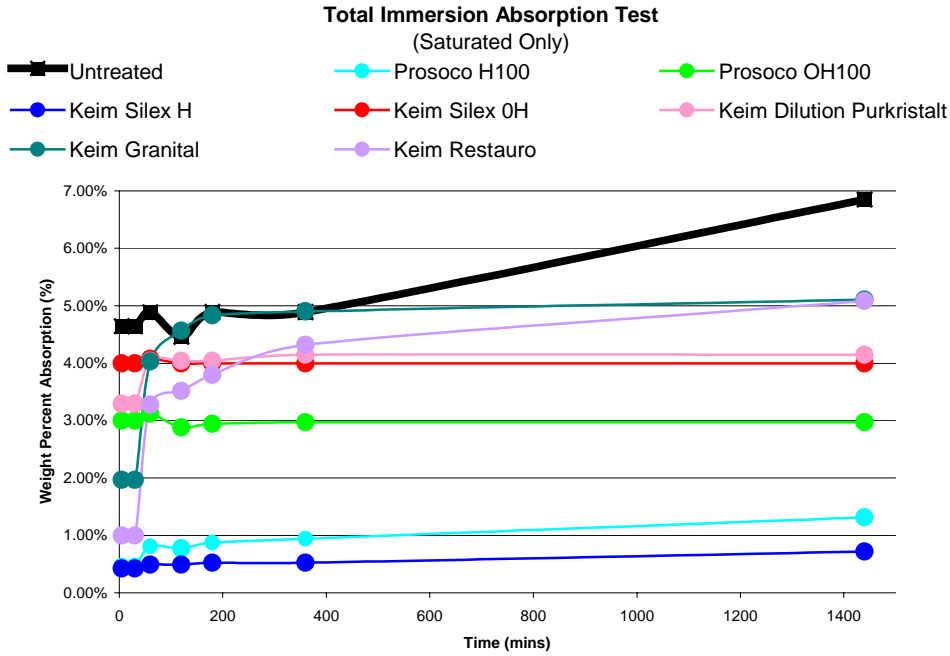
Chart 1-Total Immersion Absorption Test

The absorption tests showed that sandstone treated with Prosoco H100 & Keim Silex H greatly reduced water absorption. Consolidants should replace some of the voids left from failing binder in the material and cause water absorption to decrease. These two products were 5 times less absorptive than untreated sandstone roughly 81%. It is important to note that these were affective both when the sample was saturated and when brush applied. For testing purposes we brush applied each coating three consecutive times. It should also be noted that Prosoco OH100 cut down absorption by more than 50%. Keim Silex OH and Keim Dilution Purkristalt cut it down by more than 40%. Finally, Keim Granital and Keim Restauro cut it down by only 25%.

The following table shows the overall weight percent absorption over time of the total immersion absorption test. Note Prosoco H100 & Keim Silex H are the least absorptive as show below.

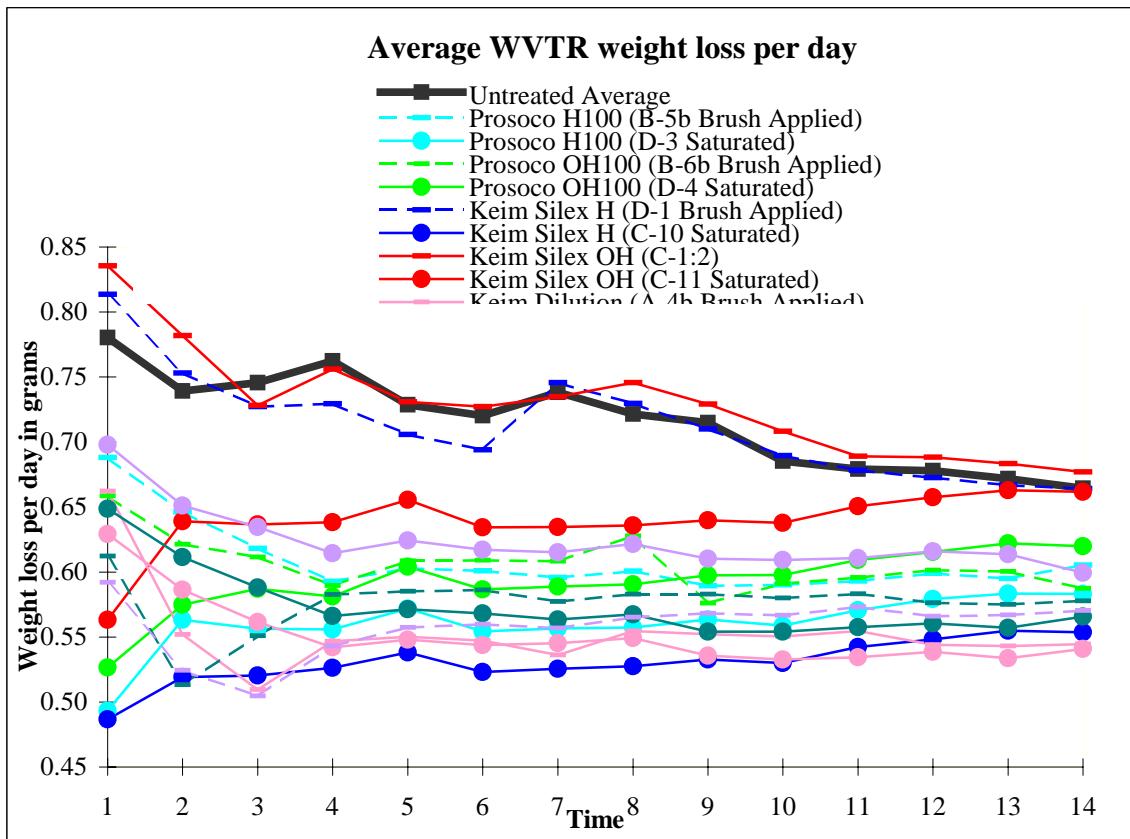
Chart 2- Average WVTR Weight Loss Per Day

The following chart reflects these the adjusted average WVTR rate for each day over a period of 15 days. The first few days' trends are typically out of sink with the rest of the readings as the sample is adjusting to the tank. The heavy black line illustrates the untreated adjusted average daily rate for multiple samples. Other samples should be compared to this line. Note the brushed applied samples of Keim Silex OH and Keim Silex H brush applied applications had rates very similar to the untreated averages. When these products were saturated their permeability decreased.
